Feasibility Report

Marie Avenue and Wesley Lane Neighborhood Improvements

City of Mendota Heights, Minnesota

City Project No. 201803
TKDA No. 16948.000

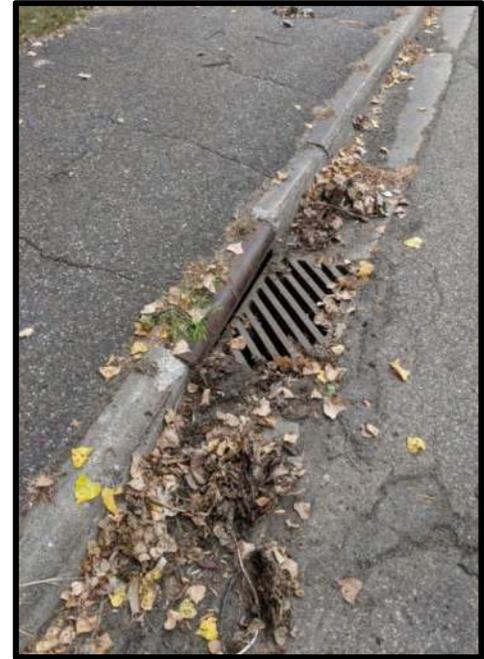
Curb and Gutter: The current condition of the curb and gutter along Marie Avenue is mostly acceptable with exception to the few areas with settling, large cracks and drainage issues. In general, the curb on Marie Avenue appears to be in better condition than the majority of curb in the Wesley Lane Neighborhood. A large majority of the curb that was in good condition had vegetation growing in the expansion joints. The vegetation seemed to be trapping sediment and other debris causing water to spill out of the gutter onto the roadway.

Curb and Gutter: Curb removal and replacement is estimated in this report at 30%. From spot checking the curb in the field, it was found that approximately 23% +/- 5% of the curb would need to be replaced. This number may fluctuate based on what curb is considered replaceable and how curb replacement impacts the budget. In addition to curb and gutter replacement, driveways impacted by replaced curb and gutter will be reconstructed to the same, or better than, previous conditions. Turf disturbed as a part of the curb replacement process will be restored with topsoil and sod (or hydro-seed where applicable).

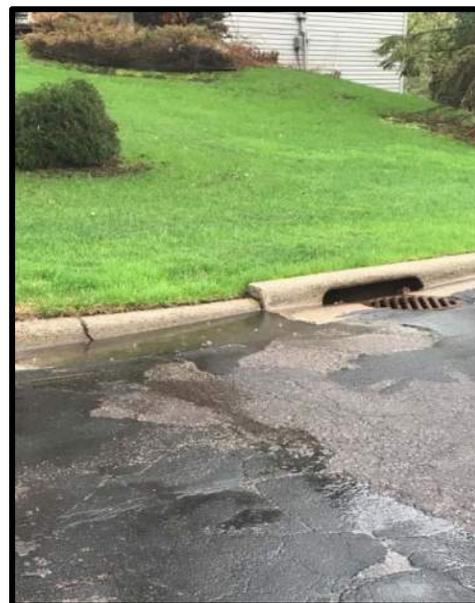
The image shows a settled piece of curb blocking drainage to a catch basin. Additionally, it can be seen that this section of roadway has been patched numerous times.

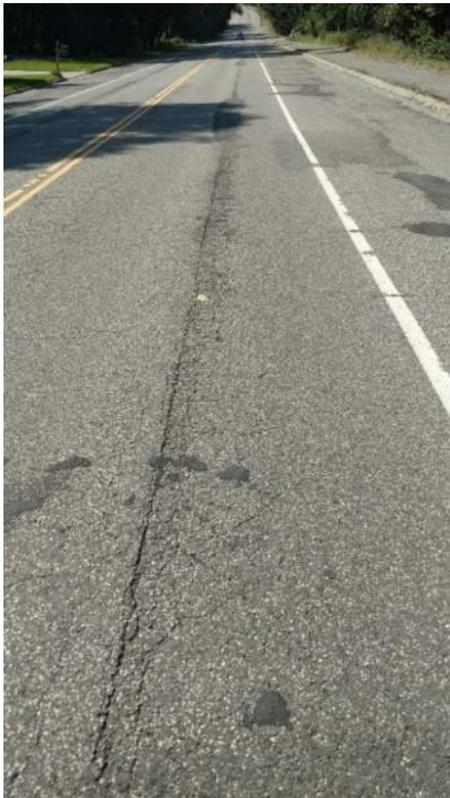
Figure 2 – Cracking in Bituminous Wear Course

There are longitudinal cracks in both traffic lanes of the bituminous wearing course, as shown in Figure 2. Some of these cracks have been patched with bituminous, as shown in Figure 3. Due to the nature of the cracking and patching, the bituminous wearing course is rated as condition state 2. Based on the Bridge Preservation and Improvement Guidelines (BPIG), replacement of the wearing surface is not required. Although the BPIG does not require replacement of the wearing surface, it is recommended to replace the bituminous wear surface with a concrete wear surface to prolong the life of the bridge. Concrete wear surfaces are a dense concrete mix that trap chlorides and protect the structural portion of the deck. After the bituminous wear course is removed, it is recommended that deck be sounded to check for any delamination. If any delamination is found, it is recommended that the area be removed and patched.

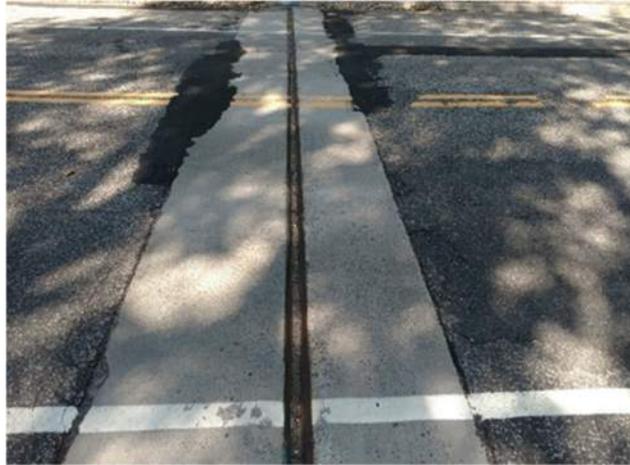
Figure 4 – Strip-seal expansion joint

The expansion joints at the west approach panel and middle of the bridge are filled with debris as shown in Figures 4 and 5. The contract plans from 1974 show a compression seal joint at the approach panels and an elastomeric expansion assembly at mid-span of the bridge. During the site inspection, it appears that the joints at the west approach panel and mid-span of the deck have been replaced with strip seal expansion joints. No records of this work have been received. These joints are filled with debris but show no indication of significant wear. The cover plates at the curbs show minor signs of rust and wear as shown in Figure 5. The condition of the strip seal expansion joints are rated as condition state 2. It is recommended to replace the strip seal expansion joints due to the age being greater than ten years which leads to difficulty in replacing the glands of the joint.

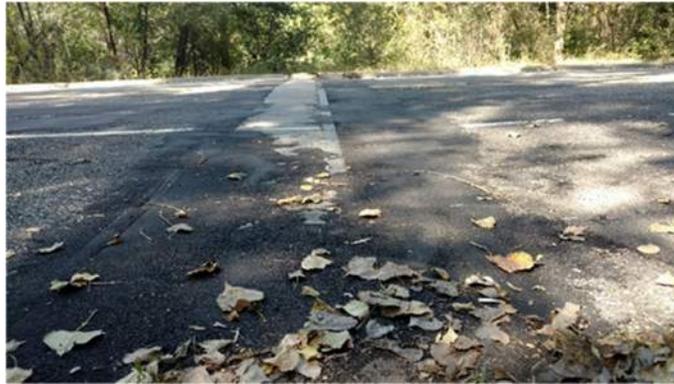
Figure 6 – East approach panel settlement and failed expansion joint

Significant settlement of the east approach panel is evident at the expansion joint. The joint is completely closed and filled with bituminous patches as shown in Figure 6. Based on the settlement of the approach panel at the expansion joint, it appears that the ledge supporting the approach panel may have failed. See Figure 7 for detail of ledge. Due to the nature of the settlement, the approach panel is rated as condition state 3. It is recommended that the approach panel be removed and replaced. During removal of the approach panel, the condition of the ledge supporting the approach panel should be investigated. If the ledge has failed, it is recommended that it be reconstructed. Also, due to the condition of the expansion joint, it is recommended that the joint be replaced with a strip-seal joint.
